# Access Compliance Report Public Rights-of-Way (Curb Ramps)

Main Street: FALABELLA\_DR Cross Street: FALABELLA\_DR Location: N

ADA ID: RPRK211202120041 Ramp Type: Type 1 - Perpendicular Initial Pass/Fail: Fail Overall Compliance: No Severity Score: 2

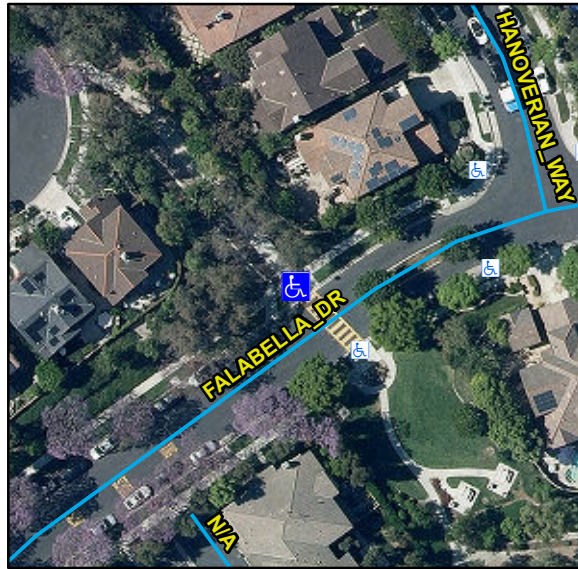
| Compliance | Description | Data | Compliance | Description | Data |
|---|---|---|---|---|---|
| No | Ramp Cross Slope (%) | 2.7 | N/A | Flare Traversable LT | N/A |

Remove & Replace Entire Ramp.

R304.5.3, STD 1115
