# Access Compliance Report Public Rights-of-Way (Curb Ramps)

Main Street: DORRANCE\_DR Cross Street: DORRANCE\_DR Location: S

ADA ID: RPRK211202120623 Ramp Type: Type 1 - Perpendicular Initial Pass/Fail: Fail Overall Compliance: No Severity Score: 15

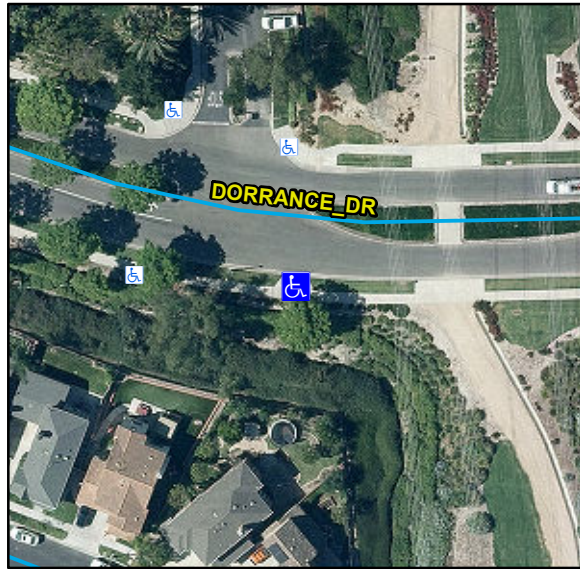
| Compliance | Description | Data | Compliance | Description | Data |
|---|---|---|---|---|---|
| No | Ramp Run Slope (%) | 8.5 | N/A | Flare Slope LT (%) | N/A |

Remove & Replace Entire Ramp.

R204.3, R304.2.2, STD 1115
