# Access Compliance Report Public Rights-of-Way (Curb Ramps)

Main Street: N/A Cross Street: DORRANCE\_DR Location: NE

ADA ID: RPRK211202120743 Ramp Type: Type 4 - Parallel Initial Pass/Fail: Fail Overall Compliance: No Severity Score: 16

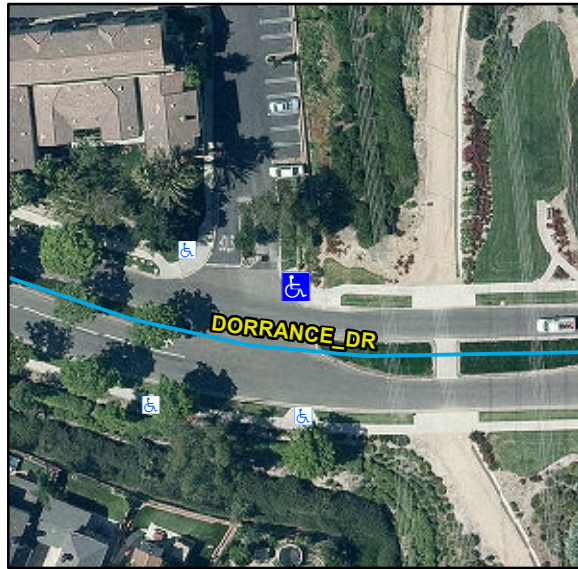
| Compliance | Description | Data | Compliance | Description | Data |
|---|---|---|---|---|---|
| Yes | Ramp Run Slope LT (%) | 1.6 | No | Ramp Run Slope RT (%) | 9.6 |
| No | Ramp Cross Slope LT (%) | 3.2 | No | Ramp Cross Slope RT (%) | 2.5 |

**Remove & Replace Curb Ramp With Two New Directional Ramps or Equivalent.**

**R204.3, R304.5.3, R304.3.2, STD 1115**
