# Access Compliance Report Public Rights-of-Way (Curb Ramps)

Main Street: DORRANCE\_DR Cross Street: N/A Location: N

ADA ID: RPRK211202121029 Ramp Type: Type 4 - Parallel Initial Pass/Fail: Pass Overall Compliance: No Severity Score: 25

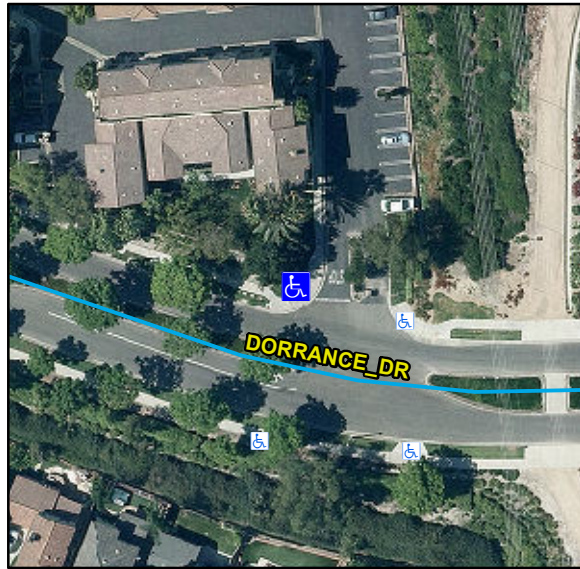
| Compliance | Description | Data | Compliance | Description | Data |
|---|---|---|---|---|---|
| N/A | Landing Present | No | No | DWS Provided | No |
| No | Landing Width (in) | N/A | N/A | DWS Length (in) | N/A |
| No | Landing Run Slope (%) | N/A | N/A | DWS Full Width | N/A |
| No | Landing Cross Slope (%) | N/A | | DWS Offset Type | N/A |
| No | Gutter Run Slope (%) | 8.1 | | Road Cross Slope (%) | 1.4 |
| Yes | Gutter Cross Slope (%) | 1.2 | No | Perpendicular Joint Present | No |

**Remove & Replace Curb Ramp With Two New Directional Ramps or Equivalent. Remove & Replace Gutter.**

**R204.3, R304.2.1, R304.2.2-Perp, R304.3.2-Para, R304.5.3, R305, R304.5.4, STD 1115**
