# Access Compliance Report Public Rights-of-Way (Curb Ramps)

Main Street: N/A Cross Street: NARROW\_CANYON\_RD Location: S

ADA ID: RPRK211202122324 Ramp Type: Type 4 - Parallel Initial Pass/Fail: Pass Overall Compliance: No Severity Score: 25

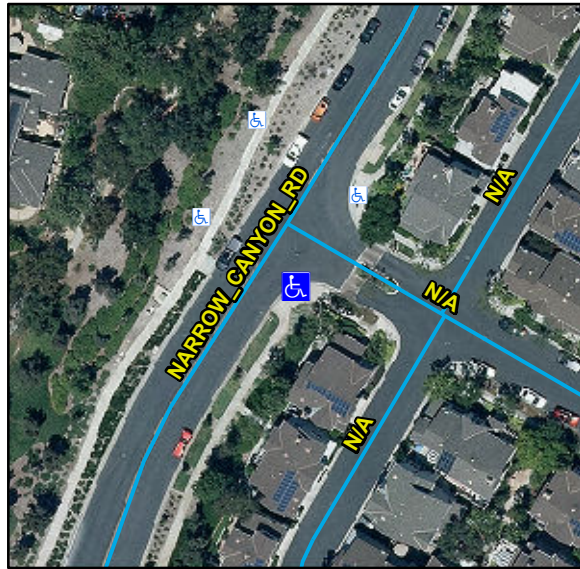
| Compliance | Description | Data | Compliance | Description | Data |
|---|---|---|---|---|---|
| No | Landing Width (in) | N/A | N/A | DWS Length (in) | N/A |
| No | Landing Run Slope (%) | N/A | N/A | DWS Full Width | N/A |
| No | Landing Cross Slope (%) | N/A | | DWS Offset Type | N/A |
| Yes | Gutter Ponding | No | No | Curb Slope | 14.1 |
| No | Gutter Run Slope (%) | 10.3 | | Road Cross Slope (%) | 4 |
| No | Gutter Cross Slope (%) | 2.3 | No | Perpendicular Joint Present | No |

Remove & Replace Curb Ramp With Two New Directional Ramps or Equivalent. Remove & Replace Gutter.
