# Access Compliance Report Public Rights-of-Way (Curb Ramps)

Main Street: N/A Cross Street: ANTONIO\_PKWY Location: N

ADA ID: RPRK211202124029 Ramp Type: Type 7 - Directional 2 Initial Pass/Fail: Fail Overall Compliance: No Severity Score: 15

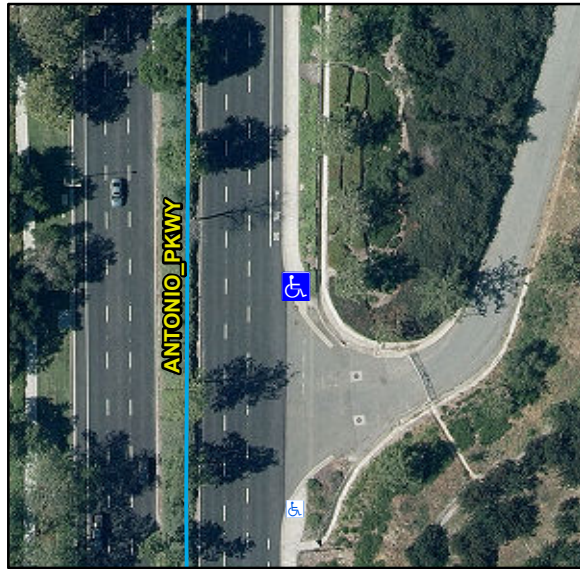
| Compliance | Description | Data | Compliance | Description | Data |
|---|---|---|---|---|---|
| <b>No</b> | Ramp Cross Slope (%) | <b>5.1</b> | <b>N/A</b> | Flare Traversable LT | <b>N/A</b> |

**Remove & Replace Entire Ramp.**

**R204.3, R304.5.3, STD 1115**
