# Access Compliance Report Public Rights-of-Way (Curb Ramps)

| Main Street: N/A | | Cross Street: ANTONIO_PKWY | | Location: S | |
| ADA ID: RPRK211202124328 | Ramp Type: Type 7 - Directional 2 | Initial Pass/Fail: Fail | Overall Compliance: No | Severity Score: 15 | |

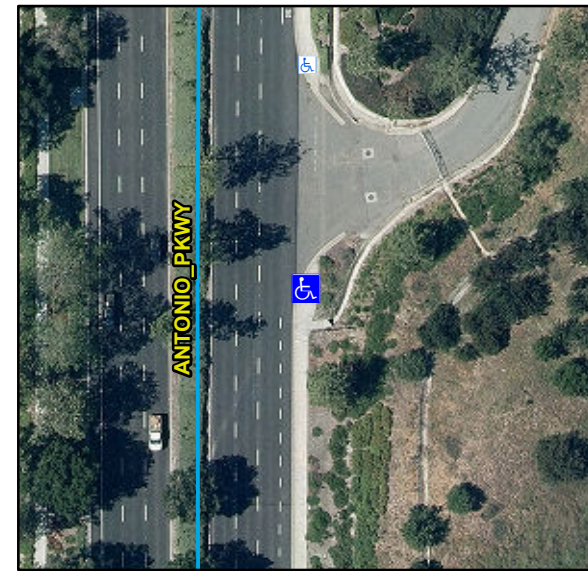
| Compliance | Description | Data | Compliance | Description | Data |
|---|---|---|---|---|---|
| No | Ramp Run Slope (%) | 10.3 | N/A | Flare Slope LT (%) | N/A |

**Remove & Replace Entire Ramp.**

**R204.3, R304.2.2, STD 1115**

Total Cost: \$ 3080
