# Access Compliance Report Public Rights-of-Way (Curb Ramps)

Main Street: ANTONIO\_PKWY Cross Street: N/A Location: SW

ADA ID: RPRK211202125650 Ramp Type: Type 1 - Perpendicular Diagonal Initial Pass/Fail: Fail Overall Compliance: No Severity Score: 2

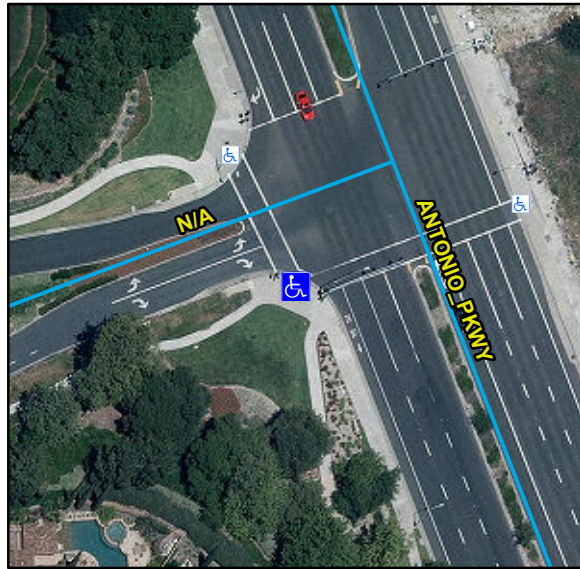
| Compliance | Description | Data | Compliance | Description | Data |
|---|---|---|---|---|---|
| No | Ramp Cross Slope (%) | 3.1 | N/A | Flare Traversable LT | N/A |
| N/A | Gutter Ponding | N/A | No | Curb Slope | 6.8 |

Remove & Replace Curb Ramp With Two New Directional Ramps or Equivalent.

R304.2.2, R204.3, R304.5.3, STD 1115
