# Access Compliance Report Public Rights-of-Way (Curb Ramps)

| Main Street: ANTONIO_PKWY | | Cross Street: N/A | | Location: | SE |
| ADA ID: RPRK211202130036 | Ramp Type: Type 4 - Parallel | Initial Pass/Fail: Fail | Overall Compliance: No | Severity Score: | 16 |

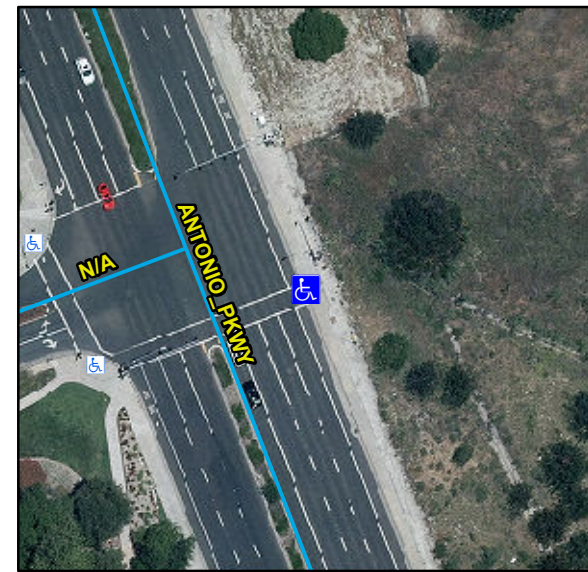
| Compliance | Description | Data | Compliance | Description | Data |
|---|---|---|---|---|---|
| No | Ramp Run Slope LT (%) | 9.5 | Yes | Ramp Run Slope RT (%) | 2.5 |
| No | Ramp Cross Slope LT (%) | 2.5 | Yes | Ramp Cross Slope RT (%) | 0.5 |

**Remove & Replace Entire Ramp.**

**R304.3.2, R304.5.3, STD 1115**

Total Cost: \$ 2000

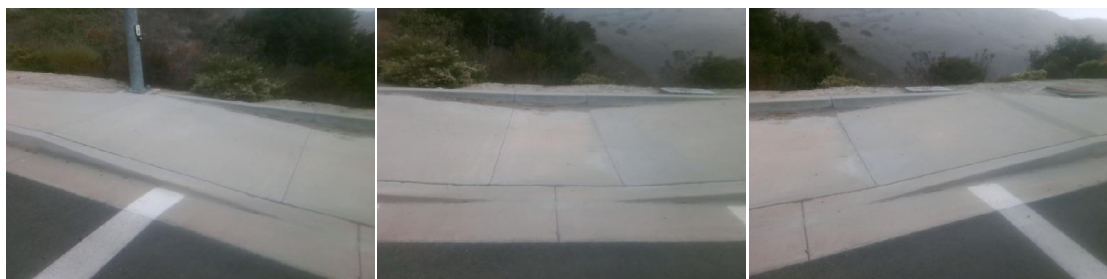
| Compliance | Description | Data | Compliance | Description | Data |
|---|---|---|---|---|---|
| N/A | Ramp Length LT (in) | 120 | N/A | Ramp Length RT (in) | 136 |
| Yes | Ramp Width LT (in) | 101 | Yes | Ramp Width RT (in) | 101 |
