# Access Compliance Report Public Rights-of-Way (Curb Ramps)

Main Street: N/A Cross Street: ANTONIO\_PKWY Location: NW

ADA ID: RPRK211202130615 Ramp Type: Type 1 - Perpendicular Diagonal Initial Pass/Fail: Fail Overall Compliance: No Severity Score: 2

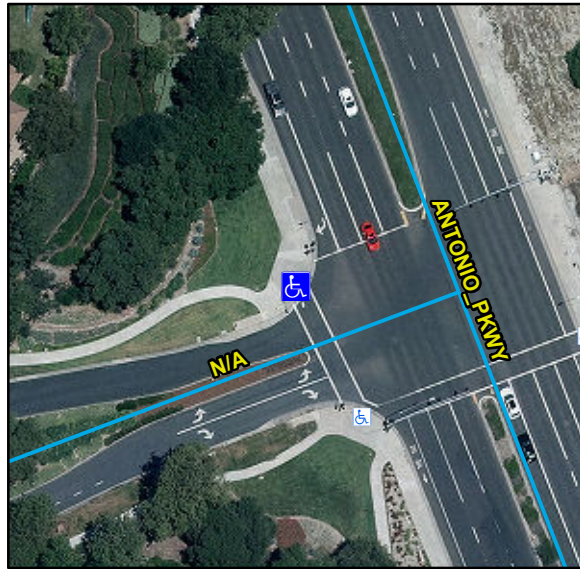
| Compliance | Description | Data | Compliance | Description | Data |
|---|---|---|---|---|---|
| No | Ramp Cross Slope (%) | 4.5 | N/A | Flare Traversable LT | N/A |
| N/A | Gutter Ponding | N/A | No | Curb Slope | 10.8 |

Remove & Replace Curb Ramp With Two New Directional Ramps or Equivalent.

R304.2.2, R204.3, R304.5.3, STD 1115

Total Cost: \$ 6160
