# Access Compliance Report Public Rights-of-Way (Curb Ramps)

Main Street: N/A Cross Street: ORTEGA\_HWY Location: E

ADA ID: RPRK211202131522 Ramp Type: Type 1 - Perpendicular Initial Pass/Fail: Pass Overall Compliance: No Severity Score: 22

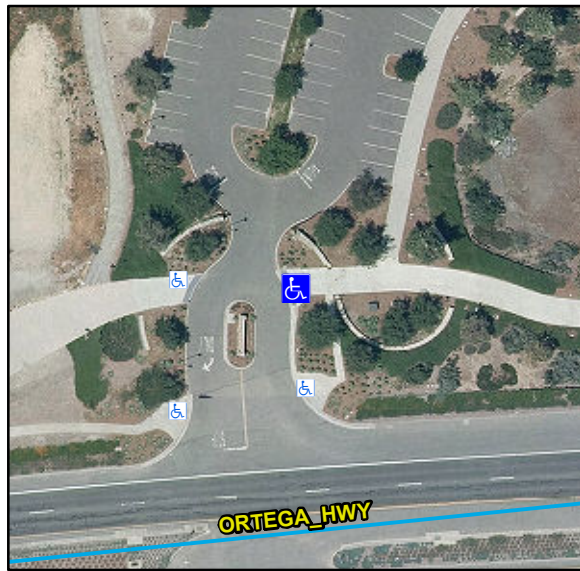
| Compliance | Description | Data | Compliance | Description | Data |
|---|---|---|---|---|---|
| No | Obstructions Present? | Yes | N/A | Utilities Present? | Yes |
| | Obstruction Types | Storm Grate | | Utility Types | |
| | Obstruction Dimensions | N/A | | Pull Box | |

Possible Solutions:

Relocate Obstruction. Utility Present.
