# Access Compliance Report Public Rights-of-Way (Curb Ramps)

Main Street: N/A Cross Street: ORTEGA\_HWY Location: W

ADA ID: RPRK211202131833 Ramp Type: Type 1 - Perpendicular Initial Pass/Fail: Pass Overall Compliance: No Severity Score: 2

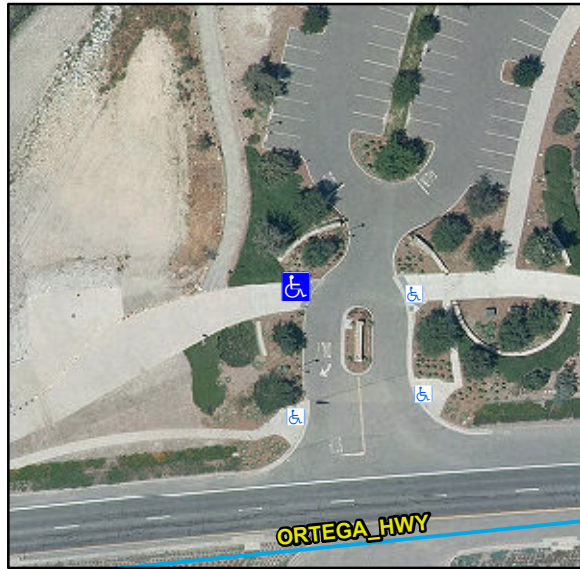
| Compliance | Description | Data | Compliance | Description | Data |
|---|---|---|---|---|---|
| No | Landing Run Slope (%) | 4.8 | N/A | Flare Traversable RT | N/A |

Remove & Replace Landing.
