# Access Compliance Report Public Rights-of-Way (Curb Ramps)

Main Street: ANDAZA\_ST Cross Street: APRENDER\_ST Location: NE

ADA ID: RPRK211202134113 Ramp Type: Type 1 - Perpendicular Initial Pass/Fail: Pass Overall Compliance: No Severity Score: 0

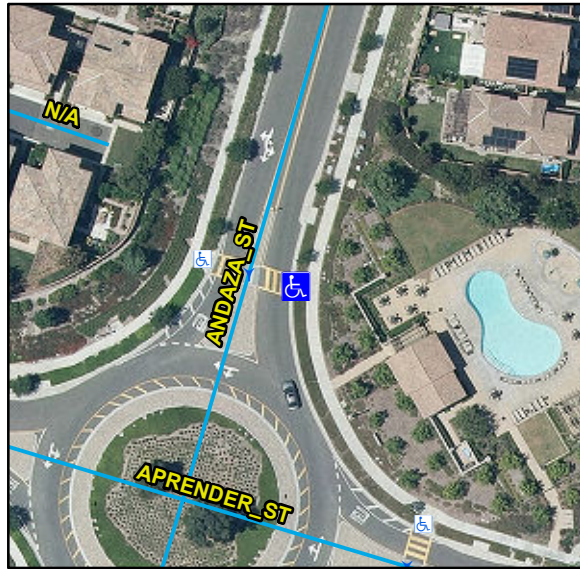
| Compliance | Description | Data | Compliance | Description | Data |
|---|---|---|---|---|---|
| Yes | Gutter Ponding | No | No | Curb Slope | 5.5 |
| No | Gutter Cross Slope (%) | 3.1 | | | |

Remove & Replace Curb Slope. Remove & Replace Gutter.
