# Access Compliance Report Public Rights-of-Way (Curb Ramps)

Main Street: ANDAZA\_ST Cross Street: APRENDER\_ST Location: NE

ADA ID: RPRK211202134716 Ramp Type: Type 1 - Perpendicular Initial Pass/Fail: Fail Overall Compliance: No Severity Score: 2

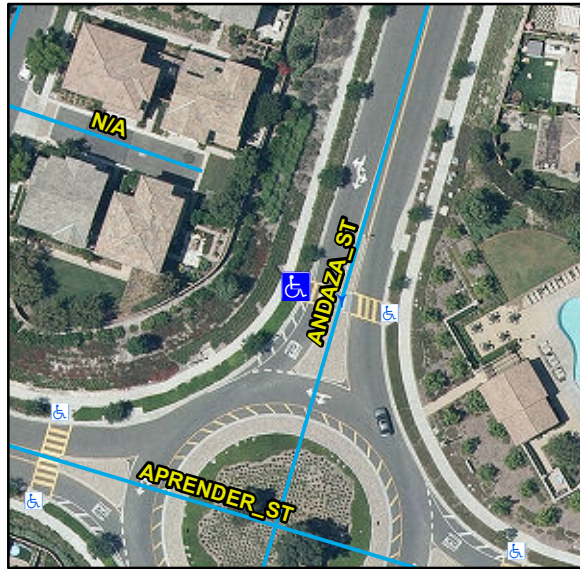
| Compliance | Description | Data | Compliance | Description | Data |
|---|---|---|---|---|---|
| No | Ramp Cross Slope (%) | 2.8 | N/A | Flare Traversable LT | N/A |

Possible Solutions:

Remove & Replace Entire Ramp.

R304.5.3, STD 1115
