# Access Compliance Report Public Rights-of-Way (Curb Ramps)

| Main Street: APRENDER_ST | | Cross Street: ANDAZA_ST | | Location: | NW |
| ADA ID: RPRK211202134853 | Ramp Type: Type 1 - Perpendicular | Initial Pass/Fail: Fail | Overall Compliance: No | Severity Score: | 2 |

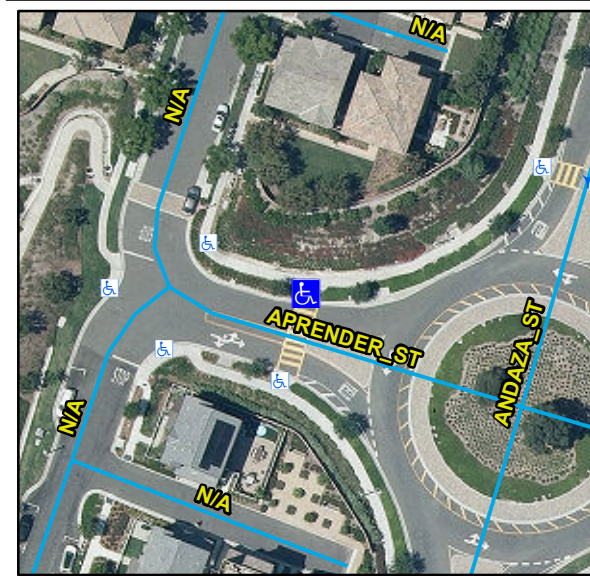
| Compliance | Description | Data | Compliance | Description | Data |
|---|---|---|---|---|---|
| No | Ramp Cross Slope (%) | 4.5 | N/A | Flare Traversable LT | N/A |

Possible Solutions:

Remove & Replace Entire Ramp.
