# Access Compliance Report Public Rights-of-Way (Curb Ramps)

Main Street: N/A Cross Street: APRENDER\_ST Location: N

ADA ID: RPRK211202135103 Ramp Type: Type 4 - Parallel Initial Pass/Fail: Fail Overall Compliance: No Severity Score: 32

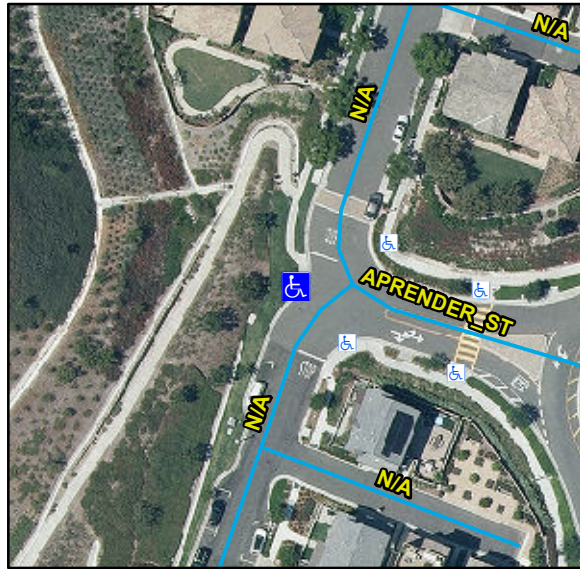
| Compliance | Description | Data | Compliance | Description | Data |
|---|---|---|---|---|---|
| N/A | Ramp Run Slope LT (%) | -9999 | No | Ramp Run Slope RT (%) | 12.4 |
| N/A | Ramp Cross Slope LT (%) | -9999 | No | Ramp Cross Slope RT (%) | 2.9 |

Possible Solutions:

Remove & Replace Entire Ramp.

R304.3.2, R304.5.3, STD 1115

\$ 2000
