# Access Compliance Report Public Rights-of-Way (Curb Ramps)

| Main Street: APRENDER_ST | | Cross Street: ANDAZA_ST | | Location: | NW |
| ADA ID: RPRK211202135554 | Ramp Type:Type 1 - Perpendicular | Initial Pass/Fail: Fail | Overall Compliance: No | Severity Score: | 2 |

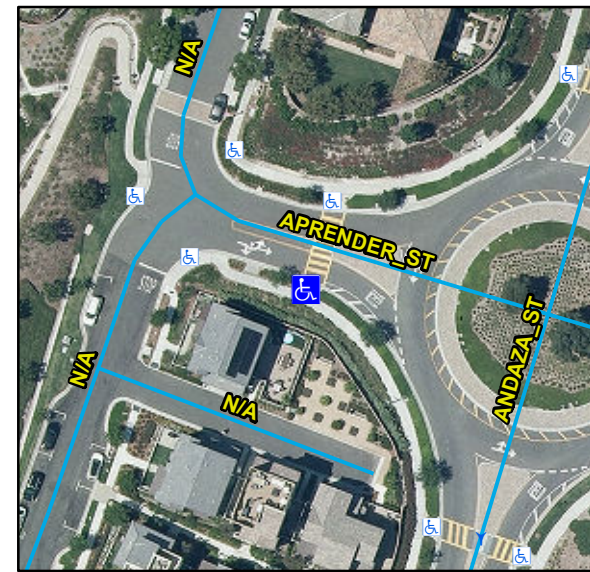
| Compliance | Description | Data | Compliance | Description | Data |
|---|---|---|---|---|---|
| No | Ramp Cross Slope (%) | 5 | N/A | Flare Traversable LT | N/A |

Possible Solutions:

Remove & Replace Entire Ramp.

R304.5.3, STD 1115
