# Access Compliance Report Public Rights-of-Way (Curb Ramps)

Main Street: ANDAZA\_ST Cross Street: APRENDER\_ST Location: SW

ADA ID: RPRK211202135755 Ramp Type: Type 1 - Perpendicular Initial Pass/Fail: Fail Overall Compliance: No Severity Score: 2

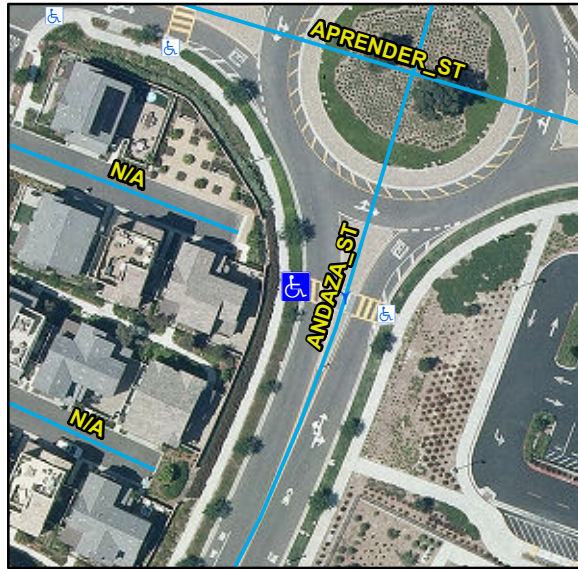
| Compliance | Description | Data | Compliance | Description | Data |
|---|---|---|---|---|---|
| No | Ramp Cross Slope (%) | 3 | N/A | Flare Traversable LT | N/A |
| N/A | Gutter Ponding | N/A | No | Curb Slope | 7 |

Remove & Replace Entire Ramp.

R304.2.2, R304.5.3, STD 1115
