# Access Compliance Report Public Rights-of-Way (Curb Ramps)

Main Street: AIROSO\_ST Cross Street: ANDAZA\_ST Location: NE

ADA ID: RPRK211203113510 Ramp Type: Type 1 - Perpendicular Initial Pass/Fail: Fail Overall Compliance: No Severity Score: 15

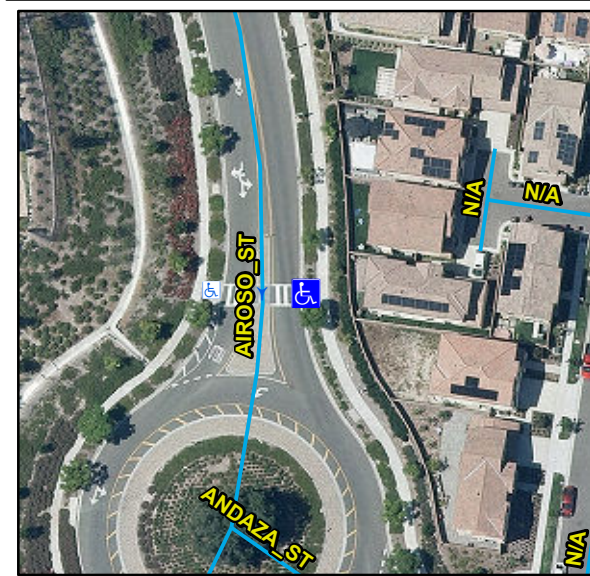
| Compliance | Description | Data | Compliance | Description | Data |
|---|---|---|---|---|---|
| No | Ramp Run Slope (%) | 9.8 | N/A | Flare Slope LT (%) | N/A |

Possible Solutions:  
Remove & Replace Entire Ramp.

OC Std/PROW:  
R304.2.2, STD 1115
