# Access Compliance Report Public Rights-of-Way (Curb Ramps)

| Main Street: AIROSO_ST | | Cross Street: ANDAZA_ST | | Location: | NE |
| ADA ID: RPRK211203114823 | Ramp Type: Type 1 - Perpendicular | Initial Pass/Fail: Fail | Overall Compliance: No | Severity Score: | 16 |

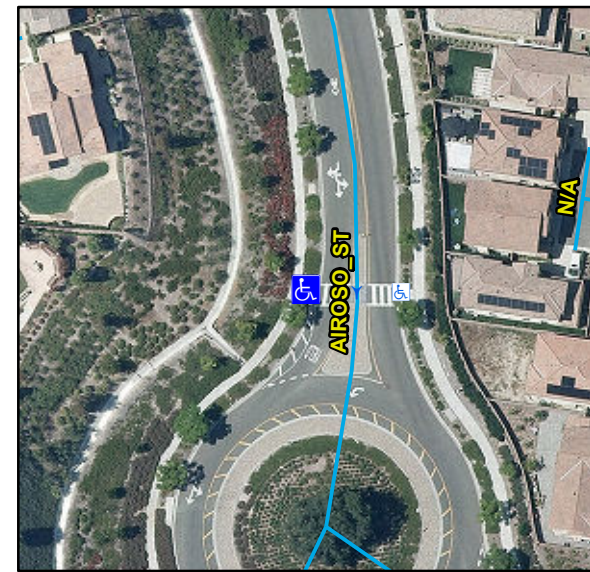
| Compliance | Description | Data | Compliance | Description | Data |
|---|---|---|---|---|---|
| No | Ramp Run Slope (%) | 9.2 | N/A | Flare Slope LT (%) | N/A |

Remove & Replace Entire Ramp.

R304.2.2, STD 1115
