# Access Compliance Report Public Rights-of-Way (Curb Ramps)

Main Street: AIROSO\_ST Cross Street: ANDAZA\_ST Location: W

ADA ID: RPRK211203120113 Ramp Type: Type 1 - Perpendicular Initial Pass/Fail: Pass Overall Compliance: No Severity Score: 0

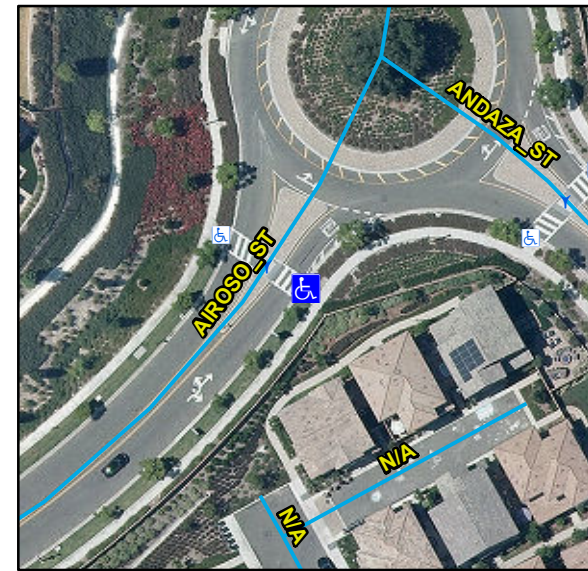
| Compliance | Description | Data | Compliance | Description | Data |
|---|---|---|---|---|---|
| No | Landing Run Slope (%) | 4.3 | N/A | Flare Traversable RT | No |

Remove & Replace Landing.

R304.2.2-Perp, R304.3.2-Para, STD 1115
