# Access Compliance Report Public Rights-of-Way (Curb Ramps)

| Main Street: ANDAZA_ST | | Cross Street: AIROSO_ST | | Location: | S |
| ADA ID: RPRK211203120744 | Ramp Type:Type 1 - Perpendicular | Initial Pass/Fail: Fail | Overall Compliance: No | Severity Score: | 15 |

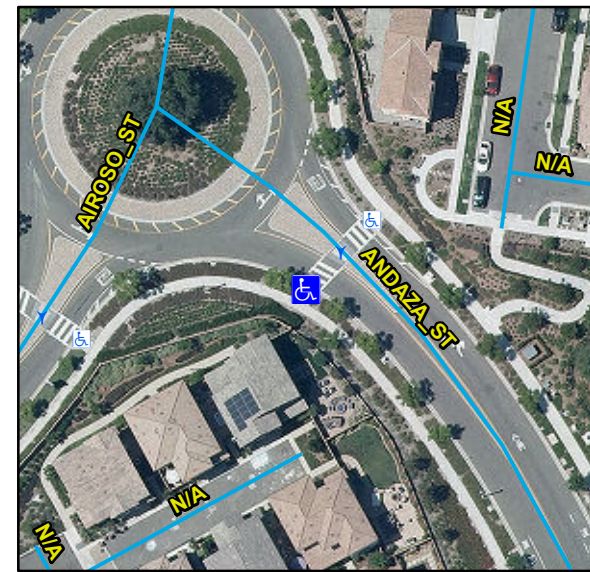
| Compliance | Description | Data | Compliance | Description | Data |
|---|---|---|---|---|---|
| No | Ramp Cross Slope (%) | 6.5 | N/A | Flare Traversable LT | N/A |

Remove & Replace Entire Ramp.

R304.5.3, STD 1115
