# Access Compliance Report Public Rights-of-Way (Curb Ramps)

Main Street: ANDAZA\_ST Cross Street: AIROSO\_ST Location: S

ADA ID: RPRK211203121651 Ramp Type: Type 1 - Perpendicular Initial Pass/Fail: Pass Overall Compliance: No Severity Score: 2

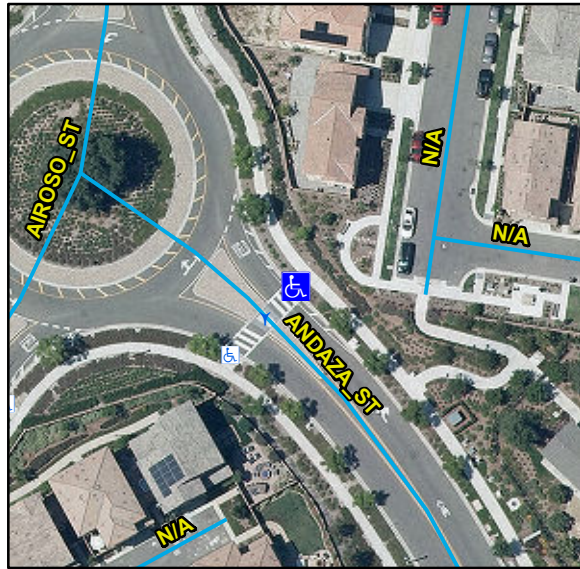
| Compliance | Description | Data | Compliance | Description | Data |
|---|---|---|---|---|---|
| No | Ramp Cross Slope (%) | 2.4 | N/A | Flare Traversable LT | No |
| No | Landing Run Slope (%) | 3.2 | N/A | Flare Traversable RT | No |
| No | Gutter Cross Slope (%) | 6.5 | | | |

Remove & Replace Entire Ramp. Remove & Replace Gutter.
