# Access Compliance Report Public Rights-of-Way (Curb Ramps)

Main Street: N/A Cross Street: ANDAZA\_ST Location: NW

ADA ID: RPRK211203122400 Ramp Type: Type 4 - Parallel Initial Pass/Fail: Fail Overall Compliance: No Severity Score: 2

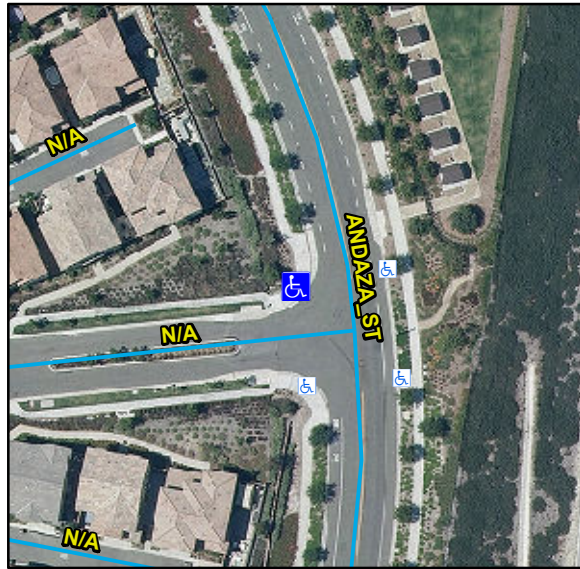
| Compliance | Description | Data | Compliance | Description | Data |
|---|---|---|---|---|---|
| Yes | Ramp Cross Slope LT (%) | 0.7 | No | Ramp Cross Slope RT (%) | 3.1 |

**Remove & Replace Curb Ramp With Two New Directional Ramps or Equivalent.**

**R304.5.3, STD 1115**
