# Access Compliance Report Public Rights-of-Way (Curb Ramps)

Main Street: ANDAZA\_ST Cross Street: N/A Location: SW

ADA ID: RPRK211203122901 Ramp Type: Type 4 - Parallel Initial Pass/Fail: Fail Overall Compliance: No Severity Score: 2

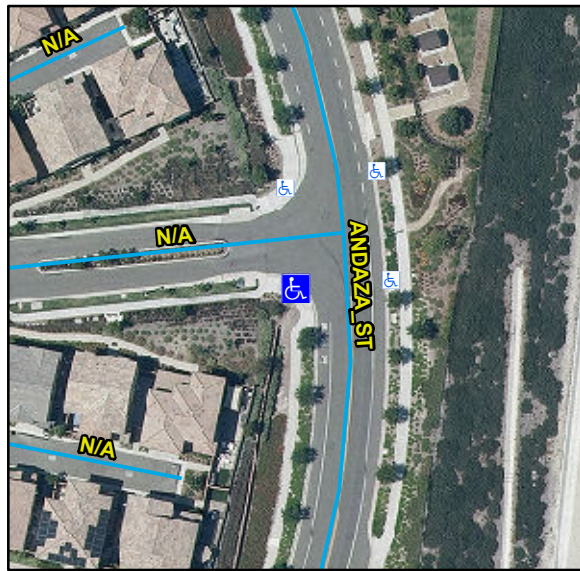
| Compliance | Description | Data | Compliance | Description | Data |
|---|---|---|---|---|---|
| Yes | Ramp Cross Slope LT (%) | 0.7 | No | Ramp Cross Slope RT (%) | 4.3 |

**Remove & Replace Curb Ramp With Two New Directional Ramps or Equivalent.**

**R304.5.3, STD 1115**

Total Cost: \$ 4000
