# Access Compliance Report Public Rights-of-Way (Curb Ramps)

Main Street: ANDAZA\_ST Cross Street: N/A Location: SE

ADA ID: RPRK211203123400 Ramp Type: Type 1 - Perpendicular Initial Pass/Fail: Fail Overall Compliance: No Severity Score: 16

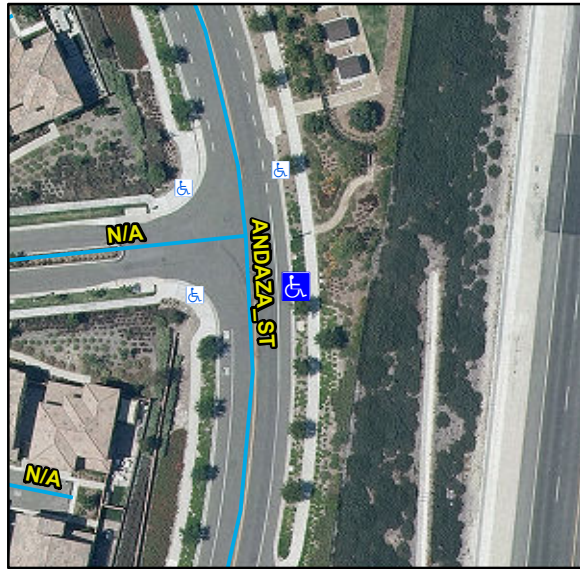
| Compliance | Description | Data | Compliance | Description | Data |
|---|---|---|---|---|---|
| No | Ramp Run Slope (%) | 9.6 | N/A | Flare Slope LT (%) | N/A |
| No | Ramp Cross Slope (%) | 3.1 | N/A | Flare Traversable LT | N/A |

Possible Solutions:

Remove & Replace Entire Ramp.

R304.2.2, R304.5.3, STD 1115
