# Access Compliance Report Public Rights-of-Way (Curb Ramps)

Main Street: N/A Cross Street: AIROSO\_ST Location: SE

ADA ID: RPRK211203125458 Ramp Type: Type 3 - Combination 1 Initial Pass/Fail: Fail Overall Compliance: No Severity Score: 16

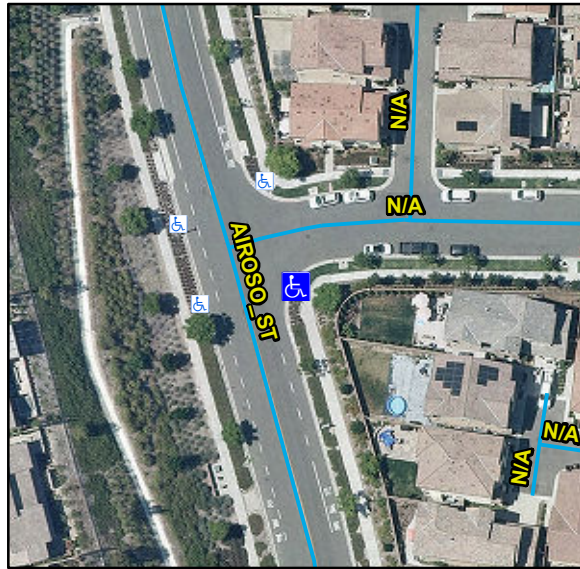
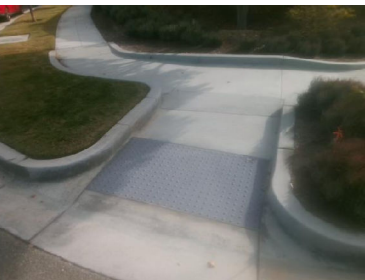
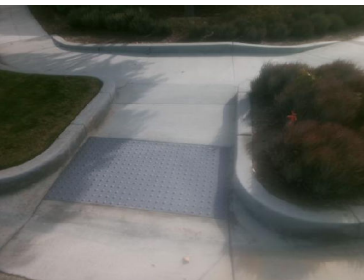
| Compliance | Description | Data | Compliance | Description | Data |
|---|---|---|---|---|---|
| Yes | Ramp Cross Slope LT (%) | 1 | No | Ramp Cross Slope RT (%) | 2.7 |
| No | Ramp Run Slope (%) | 10.5 | N/A | Flare Slope LT (%) | N/A |
| No | Ramp Cross Slope (%) | 3.9 | N/A | Flare Traversable LT | N/A |

Remove & Replace Curb Ramp With Two New Directional Ramps or Equivalent.

R304.2.2, R304.5.3, STD 1115

Total Cost: \$ 6160
