# Access Compliance Report Public Rights-of-Way (Curb Ramps)

| Main Street: AIROSO_ST | | Cross Street: N/A | | Location: | NE |
| ADA ID: RPRK211203130305 | Ramp Type: Type 3 - Combination 1 | Initial Pass/Fail: Fail | Overall Compliance: No | Severity Score: | 16 |

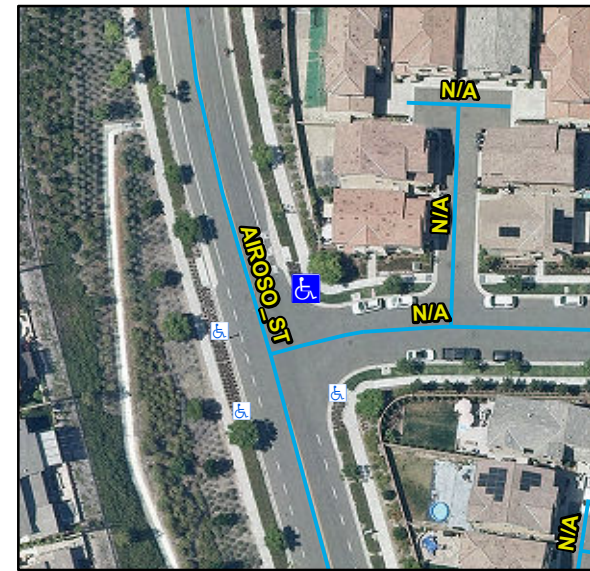
| Compliance | Description | Data | Compliance | Description | Data |
|---|---|---|---|---|---|
| No | Ramp Run Slope LT (%) | 10.7 | Yes | Ramp Run Slope RT (%) | 0.1 |
| No | Ramp Cross Slope LT (%) | 2.3 | No | Ramp Cross Slope RT (%) | 3.1 |
| No | Ramp Cross Slope (%) | 3.2 | N/A | Flare Traversable LT | N/A |

**Remove & Replace Curb Ramp With Two New Directional Ramps or Equivalent.**

**R304.5.3, R304.3.2, STD 1115**

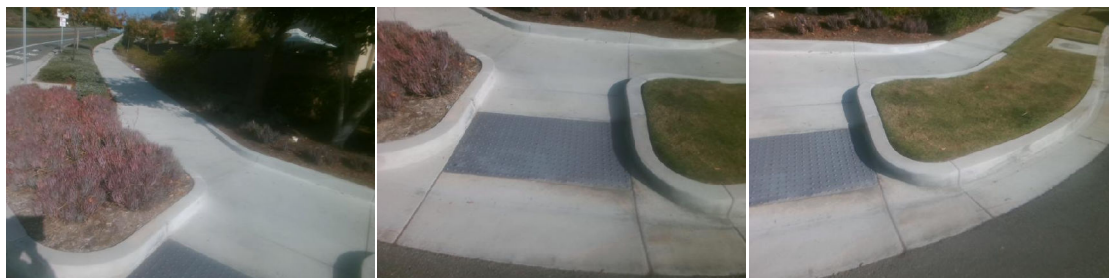
| Compliance | Description | Data | Compliance | Description | Data |
|---|---|---|---|---|---|
| N/A | Ramp Length LT (in) | 140 | N/A | Ramp Length RT (in) | 131 |
| Yes | Ramp Width LT (in) | 67 | Yes | Ramp Width RT (in) | 58 |
