# Access Compliance Report Public Rights-of-Way (Curb Ramps)

Main Street: N/A Cross Street: CONTIGO\_PL Location: W

ADA ID: RPRK211203133851 Ramp Type: Type 6 - Directional 1 Initial Pass/Fail: Pass Overall Compliance: No Severity Score: 10

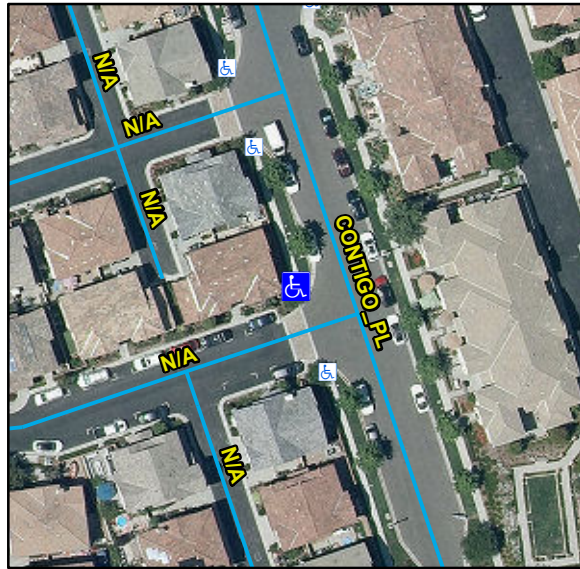
| Compliance | Description | Data | Compliance | Description | Data |
|---|---|---|---|---|---|
| No | Grade Break Slope (%) | 8.5 | | | Sloped |
| No | Landing Run Slope (%) | 6.5 | | DWS Offset Type | Single |
| No | Gutter Run Slope (%) | 5.1 | | Road Cross Slope (%) | N/A |

Remove & Replace Entire Ramp. Remove & Replace Gutter.
