# Access Compliance Report Public Rights-of-Way (Curb Ramps)

Main Street: N/A Cross Street: CONTIGO\_PL Location: W

ADA ID: RPRK211203135353 Ramp Type: Type 6 - Directional 1 Initial Pass/Fail: Pass Overall Compliance: No Severity Score: 5

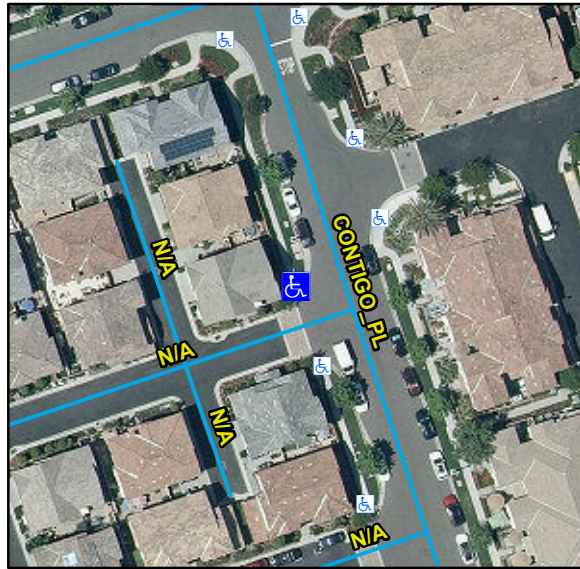
| Compliance | Description | Data | Compliance | Description | Data |
|---|---|---|---|---|---|
| No | Grade Break Slope (%) | 5.5 | | | Sloped |
| No | Landing Run Slope (%) | 5.2 | | DWS Offset Type | Single |
| No | Gutter Cross Slope (%) | 6.6 | | Parallel Ramp Side | N/A |

Remove & Replace Entire Ramp. Remove & Replace Gutter.
