# Access Compliance Report Public Rights-of-Way (Curb Ramps)

| Main Street: ST_CLOUD_DR | | Cross Street: YELLOWTAIL_DR | | Location: | SE |
| ADA ID: RPRK211206140123 | Ramp Type: Type 4 - Parallel | Initial Pass/Fail: Fail | Overall Compliance: No | Severity Score: | 15 |

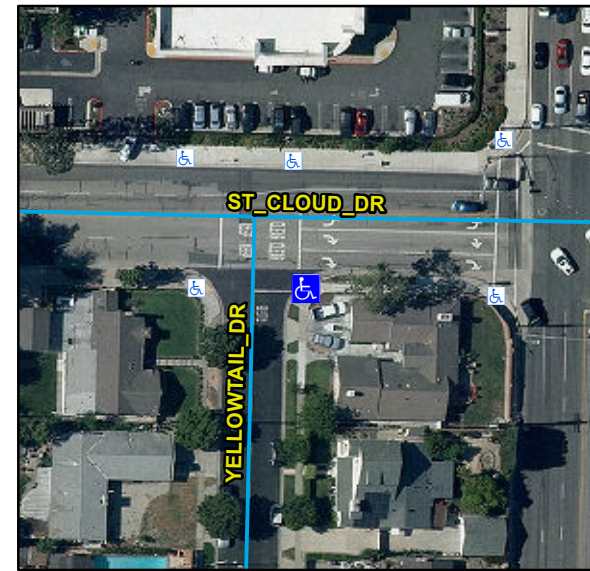
| Compliance | Description | Data | Compliance | Description | Data |
|---|---|---|---|---|---|
| Yes | Ramp Cross Slope LT (%) | 2 | No | Ramp Cross Slope RT (%) | 6.3 |

**Remove & Replace Curb Ramp With Two New Directional Ramps or Equivalent.**

**R204.3, R304.5.3, STD 1115**

Total Cost: \$ 4000
