# Access Compliance Report Public Rights-of-Way (Curb Ramps)

| Main Street: ST_CLOUD_DR | | Cross Street: ROWENA_DR | | Location: | SE |
| ADA ID: RPRK211206141051 | Ramp Type: Type 4 - Parallel | Initial Pass/Fail: Fail | Overall Compliance: No | Severity Score: | 15 |

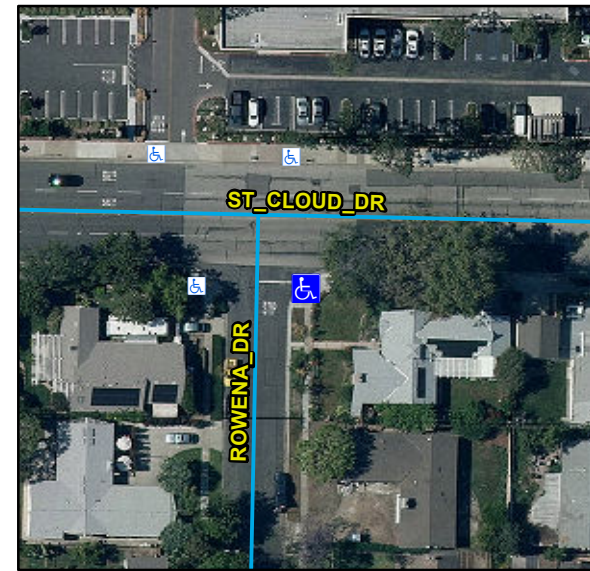
| Compliance | Description | Data | Compliance | Description | Data |
|---|---|---|---|---|---|
| No | Ramp Cross Slope LT (%) | 2.1 | No | Ramp Cross Slope RT (%) | 6.1 |

**Remove & Replace Curb Ramp With Two New Directional Ramps or Equivalent.**

**R304.5.3, STD 1115**

Total Cost: \$ 4000

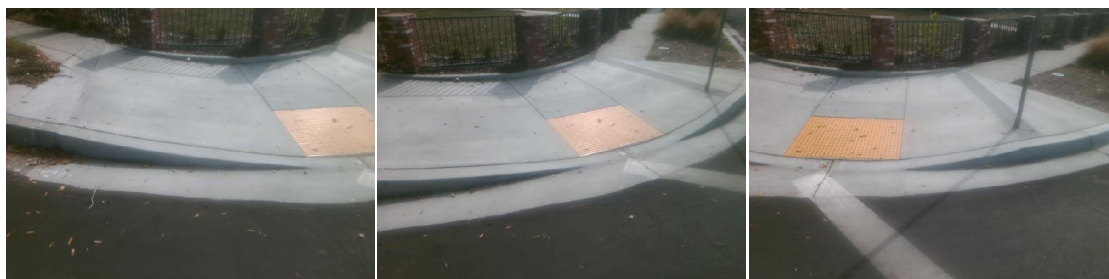
| Compliance | Description | Data | Compliance | Description | Data |
|---|---|---|---|---|---|
| N/A | Ramp Length LT (in) | 94 | N/A | Ramp Length RT (in) | 54 |
| Yes | Ramp Width LT (in) | 110 | Yes | Ramp Width RT (in) | 110 |
| Yes | Ramp Run Slope LT (%) | 8.2 | Yes | Ramp Run Slope RT (%) | 5.2 |
