# Access Compliance Report Public Rights-of-Way (Curb Ramps)

Main Street: ROWENA\_DR Cross Street: ST\_CLOUD\_DR Location: SW

ADA ID: RPRK211206141633 Ramp Type: Type 4 - Parallel Initial Pass/Fail: Fail Overall Compliance: No Severity Score: 15

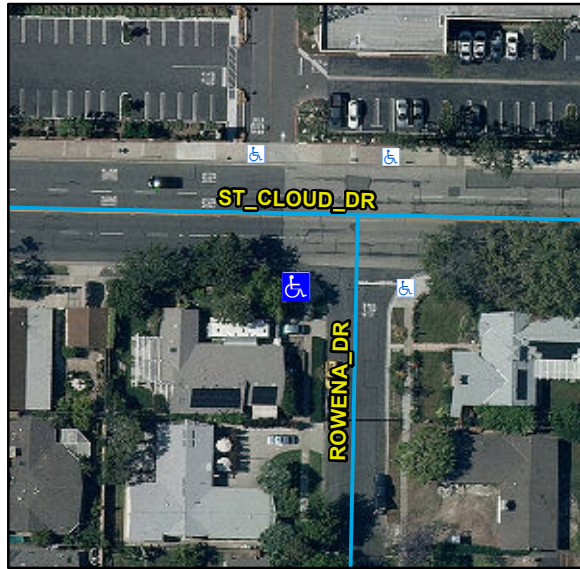
| Compliance | Description | Data | Compliance | Description | Data |
|---|---|---|---|---|---|
| No | Ramp Cross Slope LT (%) | 2.2 | No | Ramp Cross Slope RT (%) | 6.9 |

Remove & Replace Curb Ramp With Two New Directional Ramps or Equivalent.

R304.5.3, STD 1115
