# Access Compliance Report Public Rights-of-Way (Curb Ramps)

Main Street: ST\_CLOUD\_DR Cross Street: DRUID\_LN Location: NE

ADA ID: RPRK211206142914 Ramp Type: Type 4 - Parallel Initial Pass/Fail: Fail Overall Compliance: No Severity Score: 16

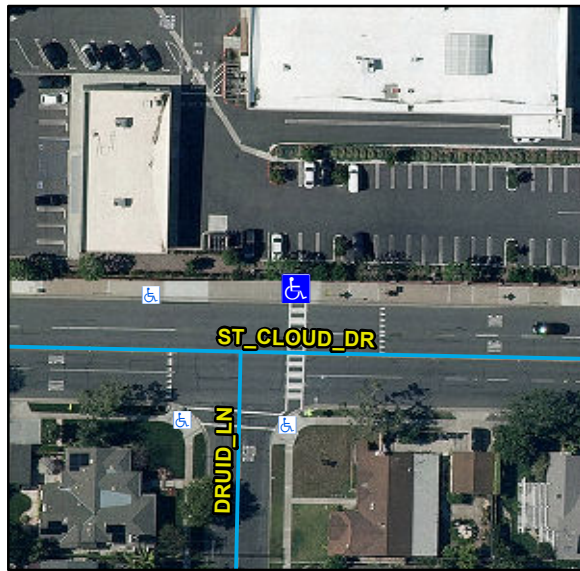
| Compliance | Description | Data | Compliance | Description | Data |
|---|---|---|---|---|---|
| No | Ramp Run Slope LT (%) | 10.3 | No | Ramp Run Slope RT (%) | 10.5 |
| Yes | Ramp Cross Slope LT (%) | 0.5 | No | Ramp Cross Slope RT (%) | 3.9 |

Remove & Replace Entire Ramp. Restripe Crosswalk.

R304.3.2, R304.5.3, STD 1115
