# Access Compliance Report Public Rights-of-Way (Curb Ramps)

Main Street: DRUID\_LN Cross Street: ST\_CLOUD\_DR Location: SW

ADA ID: RPRK211206143440 Ramp Type: Type 4 - Parallel Initial Pass/Fail: Fail Overall Compliance: No Severity Score: 15

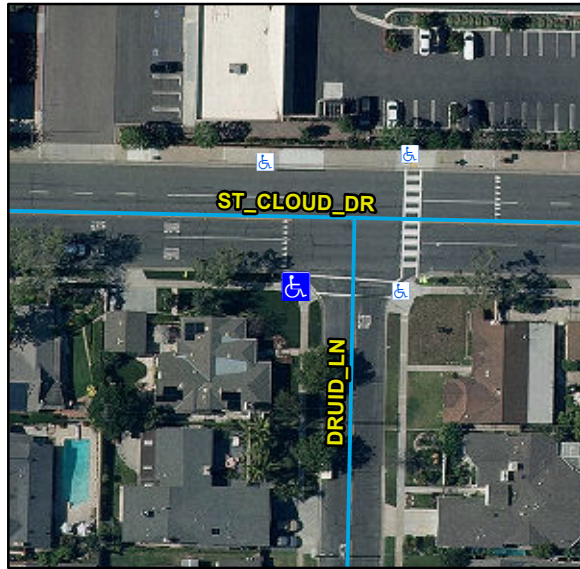
| Compliance | Description | Data | Compliance | Description | Data |
|---|---|---|---|---|---|
| No | Ramp Cross Slope LT (%) | 2.9 | No | Ramp Cross Slope RT (%) | 6.5 |

**Remove & Replace Curb Ramp With Two New Directional Ramps or Equivalent.**

**R304.5.3, STD 1115**

Total Cost: \$ 4000
