# Access Compliance Report Public Rights-of-Way (Curb Ramps)

Main Street: ST\_CLOUD\_DR Cross Street: HILLROSE\_DR Location: SE

ADA ID: RPRK211206144423 Ramp Type: Type 4 - Parallel Initial Pass/Fail: Fail Overall Compliance: No Severity Score: 30

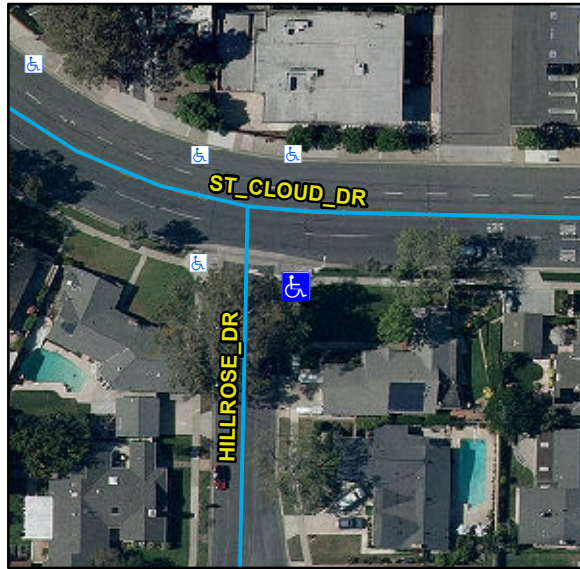
| Compliance | Description | Data | Compliance | Description | Data |
|---|---|---|---|---|---|
| Yes | Ramp Run Slope LT (%) | 4.9 | Yes | Ramp Run Slope RT (%) | 0.5 |
| No | Ramp Cross Slope LT (%) | 4.2 | No | Ramp Cross Slope RT (%) | 7.6 |

**Remove & Replace Curb Ramp With Two New Directional Ramps or Equivalent.**

**R204.3, R304.5.3, STD 1115**

Total Cost: \$ 4000
