# Access Compliance Report Public Rights-of-Way (Curb Ramps)

Main Street: HILLROSE\_DR Cross Street: ST\_CLOUD\_DR Location: SW

ADA ID: RPRK211206145010 Ramp Type: Type 4 - Parallel Initial Pass/Fail: Fail Overall Compliance: No Severity Score: 15

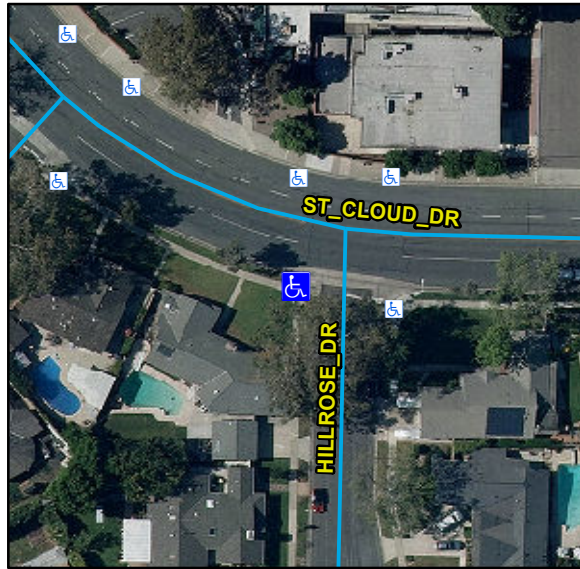
| Compliance | Description | Data | Compliance | Description | Data |
|---|---|---|---|---|---|
| Yes | Ramp Cross Slope LT (%) | 1.4 | No | Ramp Cross Slope RT (%) | 6 |

Remove & Replace Curb Ramp With Two New Directional Ramps or Equivalent.

R204.3, R304.5.3, STD 1115

Total Cost: \$ 4000
