# Access Compliance Report Public Rights-of-Way (Curb Ramps)

Main Street: ST\_CLOUD\_DR Cross Street: TIGERTAIL\_DR Location: S

ADA ID: RPRK211206145618 Ramp Type: Type 4 - Parallel Initial Pass/Fail: Fail Overall Compliance: No Severity Score: 30

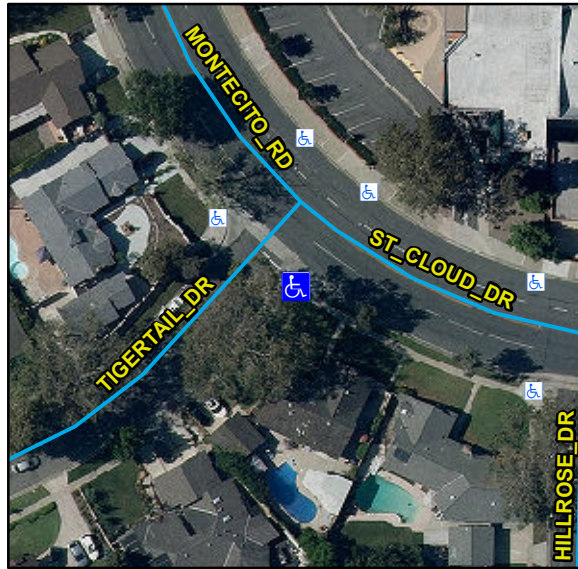
| Compliance | Description | Data | Compliance | Description | Data |
|---|---|---|---|---|---|
| No | Ramp Cross Slope LT (%) | 4.9 | No | Ramp Cross Slope RT (%) | 8.9 |

Remove & Replace Curb Ramp With Two New Directional Ramps or Equivalent.

R304.5.3, STD 1115
