# Access Compliance Report Public Rights-of-Way (Curb Ramps)

| Main Street: TIGERTAIL_DR | | Cross Street: MONTECITO_RD | | Location: | W |
| ADA ID: RPRK211206150324 | Ramp Type: Type 4 - Parallel | Initial Pass/Fail: Fail | Overall Compliance: No | Severity Score: | 30 |

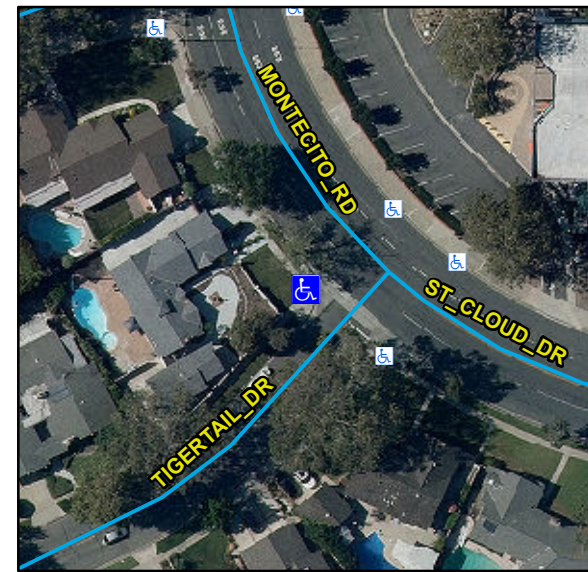
| Compliance | Description | Data | Compliance | Description | Data |
|---|---|---|---|---|---|
| No | Ramp Run Slope LT (%) | 8.9 | Yes | Ramp Run Slope RT (%) | 7.1 |
| Yes | Ramp Cross Slope LT (%) | 1.4 | No | Ramp Cross Slope RT (%) | 5.2 |

**Remove & Replace Curb Ramp With Two New Directional Ramps or Equivalent.**

**R304.3.2, R304.5.3, STD 1115**

Total Cost: \$ 4000

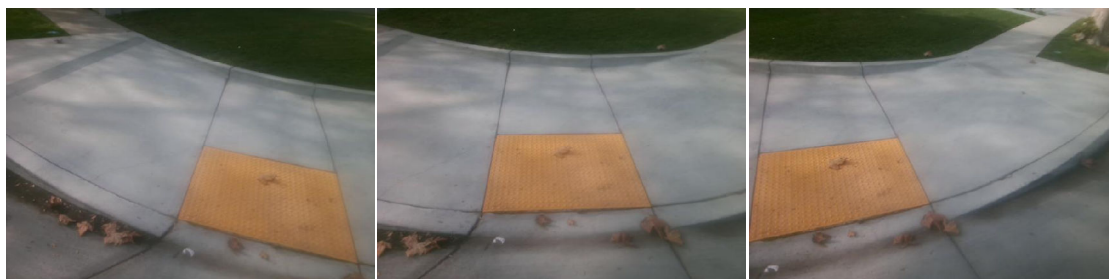
| Compliance | Description | Data | Compliance | Description | Data |
|---|---|---|---|---|---|
| N/A | Ramp Length LT (in) | 81 | N/A | Ramp Length RT (in) | 83 |
| Yes | Ramp Width LT (in) | 108 | Yes | Ramp Width RT (in) | 108 |
