# Access Compliance Report Public Rights-of-Way (Curb Ramps)

| Main Street: MONTECITO_RD | | Cross Street: BRIMHALL_DR | | Location: | SW |
| ADA ID: RPRK211206151026 | Ramp Type: Type 4 - Parallel | Initial Pass/Fail: Fail | Overall Compliance: No | Severity Score: | 30 |

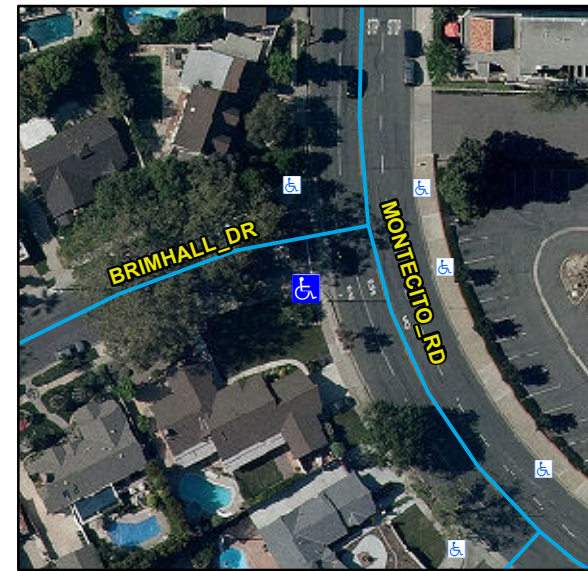
| Compliance | Description | Data | Compliance | Description | Data |
|---|---|---|---|---|---|
| Yes | Ramp Cross Slope LT (%) | 0 | No | Ramp Cross Slope RT (%) | 7.1 |

**Remove & Replace Curb Ramp With Two New Directional Ramps or Equivalent.**

**R204.3, R304.5.3, STD 1115**

Total Cost: \$ 4000

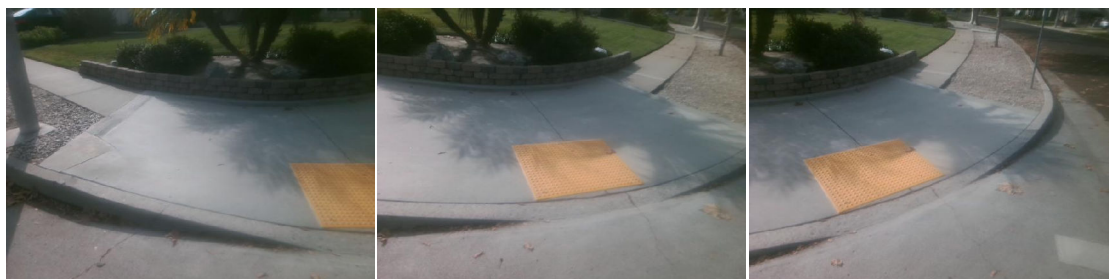
| Compliance | Description | Data | Compliance | Description | Data |
|---|---|---|---|---|---|
| N/A | Ramp Length LT (in) | 113 | N/A | Ramp Length RT (in) | 108 |
| Yes | Ramp Width LT (in) | 112 | Yes | Ramp Width RT (in) | 112 |
| Yes | Ramp Run Slope LT (%) | 6.3 | Yes | Ramp Run Slope RT (%) | 0.8 |
