# Access Compliance Report Public Rights-of-Way (Curb Ramps)

| Main Street: BRIMHALL_DR | | Cross Street: MONTECITO_RD | | Location: | NW |
| ADA ID: RPRK211206151651 | Ramp Type: Type 4 - Parallel | Initial Pass/Fail: Fail | Overall Compliance: No | Severity Score: | 15 |

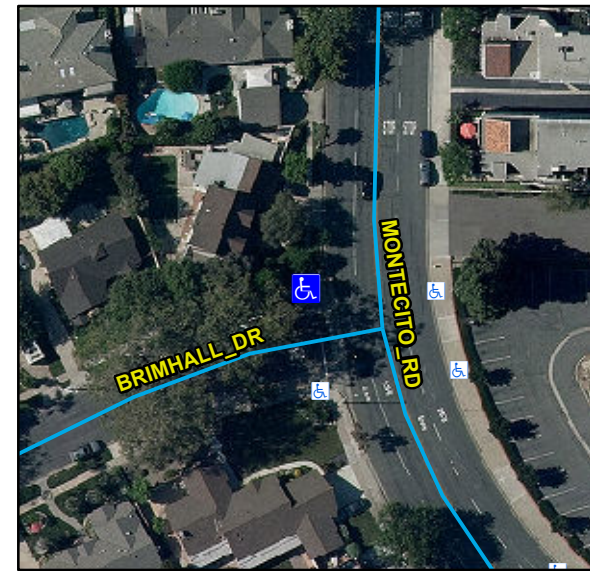
| Compliance | Description | Data | Compliance | Description | Data |
|---|---|---|---|---|---|
| No | Ramp Cross Slope LT (%) | 2.5 | No | Ramp Cross Slope RT (%) | 5.4 |

**Remove & Replace Curb Ramp With Two New Directional Ramps or Equivalent.**

**R304.5.3, STD 1115**

Total Cost: \$ 4000
