# Access Compliance Report Public Rights-of-Way (Curb Ramps)

Main Street: ST\_CLOUD\_DR Cross Street: SEAL\_BEACH\_BLV Location: SE

ADA ID: RPRK211206154540 Ramp Type: Type 1 - Perpendicular Diagonal Initial Pass/Fail: Fail Overall Compliance: No Severity Score: 15

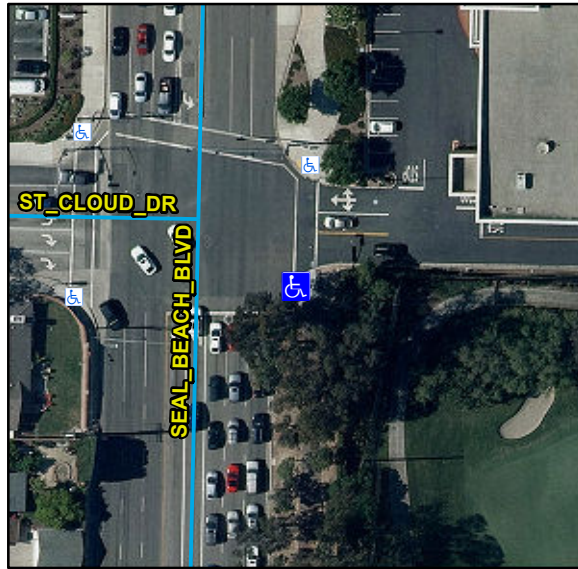
| Compliance | Description | Data | Compliance | Description | Data |
|---|---|---|---|---|---|
| No | Ramp Run Slope (%) | 11.3 | N/A | Flare Slope LT (%) | N/A |

**Remove & Replace Curb Ramp With Two New Directional Ramps or Equivalent. Restripe Crosswalk.**

**R304.2.2, STD 1115**
