# Access Compliance Report Public Rights-of-Way (Curb Ramps)

Main Street: SEAL\_BEACH\_BLVD Cross Street: ST\_CLOUD\_DR Location: NE

ADA ID: RPRK211206155107 Ramp Type: Type 1 - Perpendicular Diagonal Initial Pass/Fail: Fail Overall Compliance: No Severity Score: 15

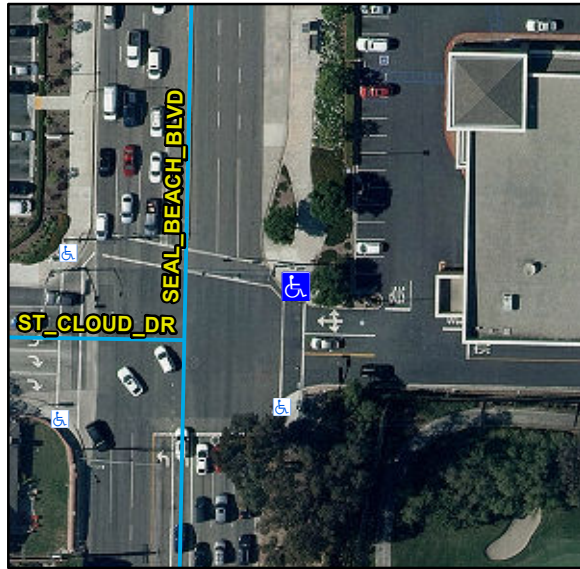
| Compliance | Description | Data | Compliance | Description | Data |
|---|---|---|---|---|---|
| No | Ramp Run Slope (%) | 10.2 | N/A | Flare Slope LT (%) | N/A |

Remove & Replace Curb Ramp With Two New Directional Ramps or Equivalent.

R204.3, R304.2.2, STD 1115
