# Access Compliance Report Public Rights-of-Way (Curb Ramps)

Main Street: ST\_CLOUD\_DR Cross Street: SEAL\_BEACH\_BLVD Location: NW

ADA ID: RPRK211206160821 Ramp Type: Type 4 - Parallel Initial Pass/Fail: Fail Overall Compliance: No Severity Score: 2

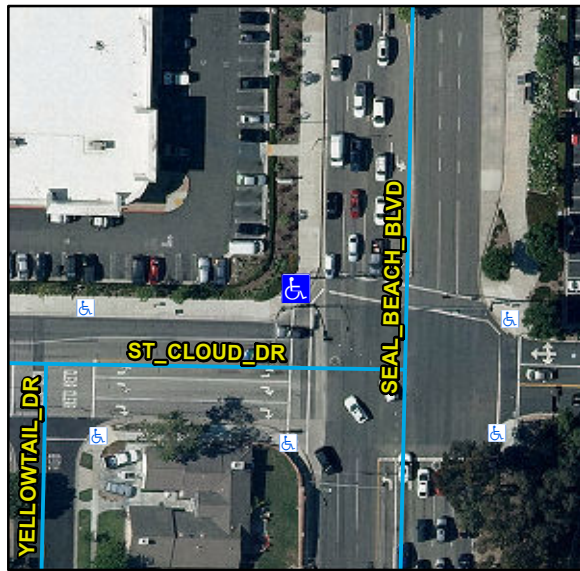
| Compliance | Description | Data | Compliance | Description | Data |
|---|---|---|---|---|---|
| No | Ramp Cross Slope LT (%) | 2.6 | No | Ramp Cross Slope RT (%) | 3.3 |

Remove & Replace Curb Ramp With Two New Directional Ramps or Equivalent. Restripe Crosswalk.

R304.5.3, STD 1115
