# Access Compliance Report Public Rights-of-Way (Curb Ramps)

Main Street: SILVER\_FOX\_RD Cross Street: YELLOWTAIL\_DR Location: NE

ADA ID: RPRK211206163519 Ramp Type: Type 4 - Parallel Initial Pass/Fail: Fail Overall Compliance: No Severity Score: 2

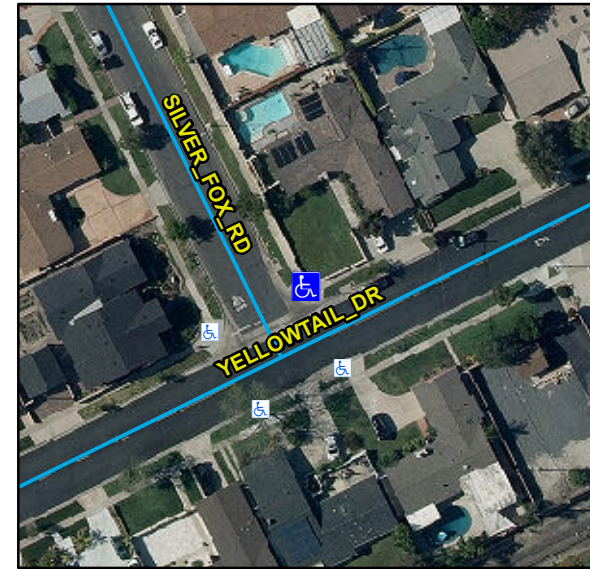
| Compliance | Description | Data | Compliance | Description | Data |
|---|---|---|---|---|---|
| Yes | Ramp Cross Slope LT (%) | 2 | No | Ramp Cross Slope RT (%) | 2.2 |

Possible Solutions:  
**Remove & Replace Curb Ramp With Two New Directional Ramps or Equivalent.**

OC Std/PROW:  
**R204.3, R304.5.3, STD 1115**

Total Cost: \$ 4000
