# Access Compliance Report Public Rights-of-Way (Curb Ramps)

| Main Street: YELLOWTAIL_DR | | Cross Street: SILVER_FOX_RD | | Location: | NW |
| ADA ID: RPRK211206164726 | Ramp Type: Type 4 - Parallel | Initial Pass/Fail: Fail | Overall Compliance: No | Severity Score: | 30 |

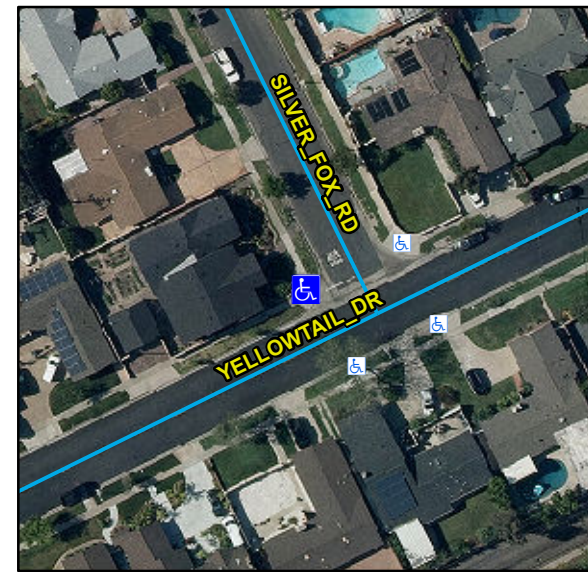
| Compliance | Description | Data | Compliance | Description | Data |
|---|---|---|---|---|---|
| No | Ramp Cross Slope LT (%) | 6 | No | Ramp Cross Slope RT (%) | 10.3 |
| N/A | Gutter Cross Slope (%) | N/A | No | Perpendicular Joint Present | No |

**Remove & Replace Curb Ramp With Two New Directional Ramps or Equivalent.**

**R204.3, R304.5.3, STD 1115**

Total Cost: \$ 4000

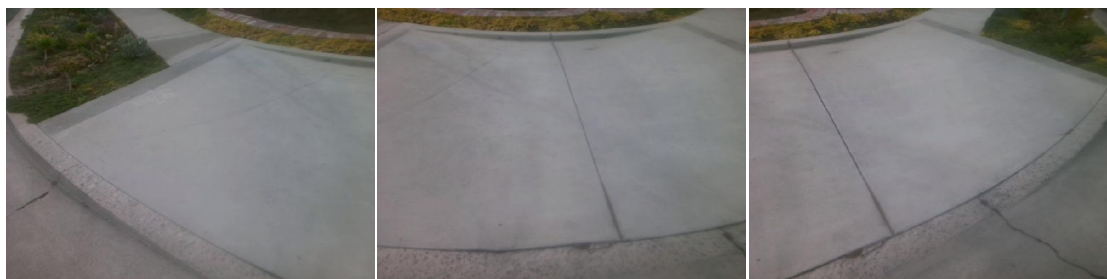
| Compliance | Description | Data | Compliance | Description | Data |
|---|---|---|---|---|---|
| N/A | Ramp Length LT (in) | 107 | N/A | Ramp Length RT (in) | 111 |
| Yes | Ramp Width LT (in) | 124 | Yes | Ramp Width RT (in) | 124 |
| Yes | Ramp Run Slope LT (%) | 2 | Yes | Ramp Run Slope RT (%) | 6 |
