# Access Compliance Report Public Rights-of-Way (Curb Ramps)

Main Street: ROWENA\_DR Cross Street: SILVER\_FOX\_RD Location: SE

ADA ID: RPRK211206165333 Ramp Type: Type 1 - Perpendicular Diagonal Initial Pass/Fail: Fail Overall Compliance: No Severity Score: 2

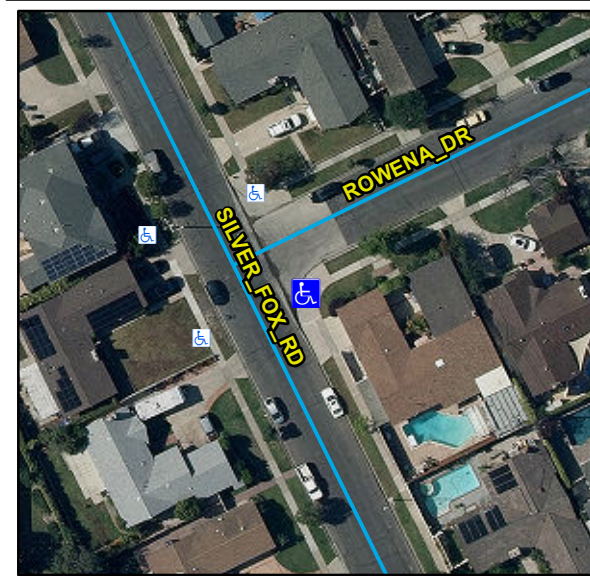
| Compliance | Description | Data | Compliance | Description | Data |
|---|---|---|---|---|---|
| No | Ramp Cross Slope (%) | 2.9 | N/A | Flare Traversable LT | N/A |

Possible Solutions:  
**Remove & Replace Curb Ramp With Two New Directional Ramps or Equivalent.**

OC Std/PROW:  
**R204.3, R304.5.3, STD 1115**

Total Cost: \$ 6160
