# Access Compliance Report Public Rights-of-Way (Curb Ramps)

Main Street: SILVER\_FOX\_RD Cross Street: ROWENA\_DR Location: NE

ADA ID: RPRK211206165548 Ramp Type: Type 1 - Perpendicular Diagonal Initial Pass/Fail: Fail Overall Compliance: No Severity Score: 15

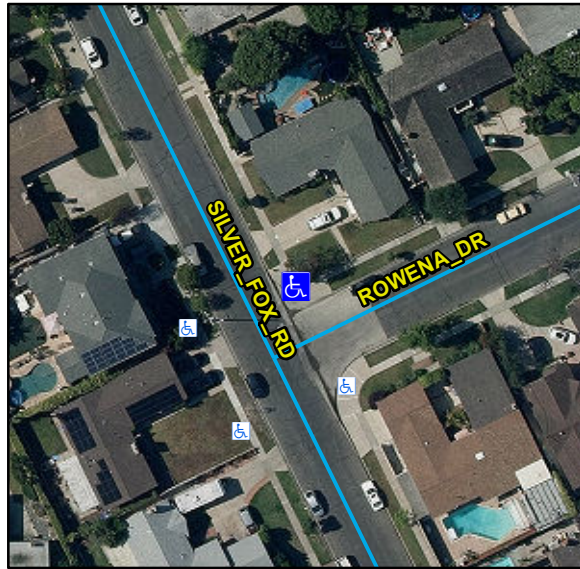
| Compliance | Description | Data | Compliance | Description | Data |
|---|---|---|---|---|---|
| No | Ramp Run Slope (%) | 8.4 | N/A | Flare Slope LT (%) | N/A |
| No | Gutter Lip Height (in) | 0.25 | | Road Run Slope (%) | 2.8 |

Remove & Replace Curb Ramp With Two New Directional Ramps or Equivalent. Grind Gutter Lip.

R204.3, R304.2.2, R302.7.2, STD 1115
