# Access Compliance Report Public Rights-of-Way (Curb Ramps)

Main Street: SILVER\_FOX\_RD Cross Street: DRUID\_LN Location: SW

ADA ID: RPRK211206165841 Ramp Type: Type 1 - Perpendicular Diagonal Initial Pass/Fail: Pass Overall Compliance: No Severity Score: 10

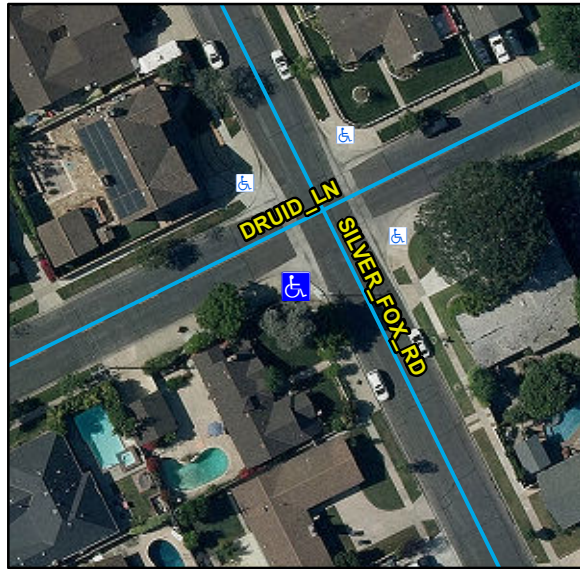
| Compliance | Description | Data | Compliance | Description | Data |
|---|---|---|---|---|---|
| Yes | Landing Cross Slope (%) | 1.6 | No | DWS Provided | No |
| Yes | Gutter Ponding | No | No | Curb Slope | 8.9 |

**Remove & Replace Curb Ramp With Two New Directional Ramps or Equivalent.**

**R304.2.2, R204.3, R305, STD 1115**
