# Access Compliance Report Public Rights-of-Way (Curb Ramps)

Main Street: DRUID\_LN Cross Street: SILVER\_FOX\_RD Location: NW

ADA ID: RPRK211206170449 Ramp Type: Type 1 - Perpendicular Diagonal Initial Pass/Fail: Pass Overall Compliance: No Severity Score: 15

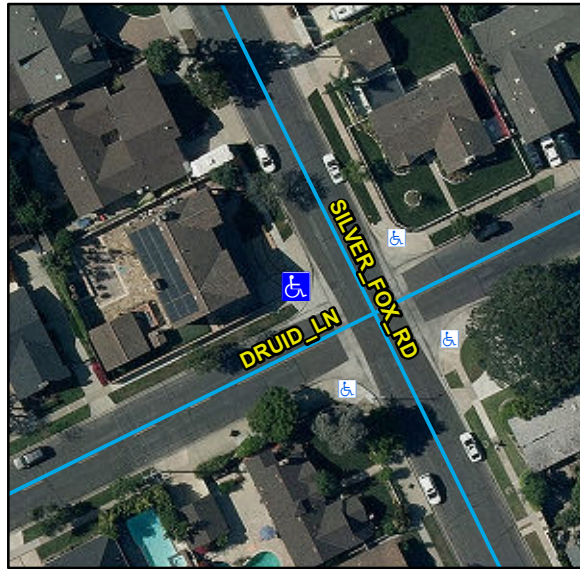
| Compliance | Description | Data | Compliance | Description | Data |
|---|---|---|---|---|---|
| Yes | Landing Cross Slope (%) | 2 | No | DWS Provided | No |
| No | Gutter Run Slope (%) | 5.3 | | Road Cross Slope (%) | 3.5 |
| No | Gutter Cross Slope (%) | 3 | | | |

Remove & Replace Curb Ramp With Two New Directional Ramps or Equivalent. Remove & Replace Gutter.
